Manhole Inspection Summary

Manhole # S31GG_067MH

Location Address: **1216 JOHN ST**

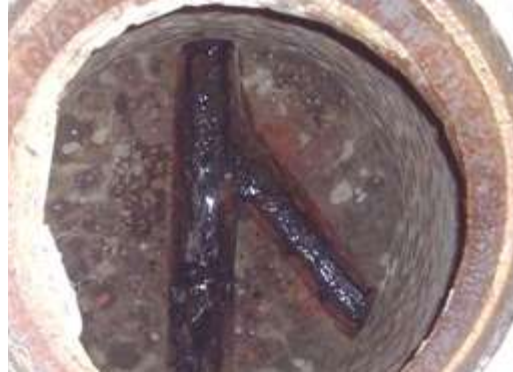
Top View

Adjustment loose brick. Bench and Channel debris.

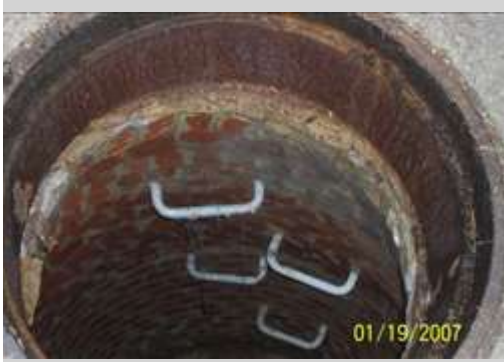
Defect

Frame offset. Adjustment deterioration and infiltration. Corbel infiltration.

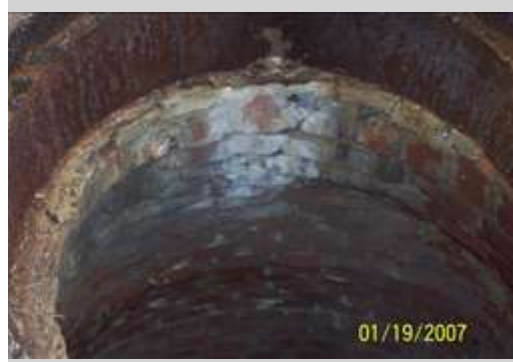
Defect

Adjustment deterioration and infiltration. Corbel infiltration.

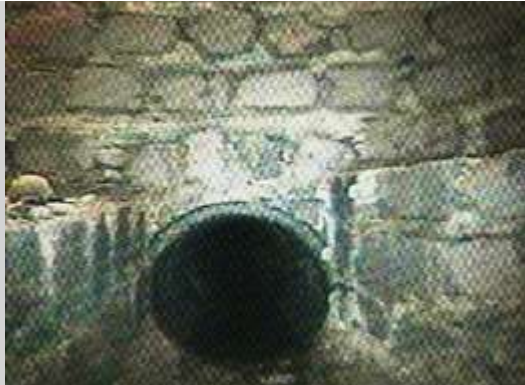
8 in. Circular Gravity Sewer Pipe Out @ 12 O'Clock

Barrel deterioration and infiltration.

Infiltration: **Evidence** Pipe Seal Cond: **Unknown**

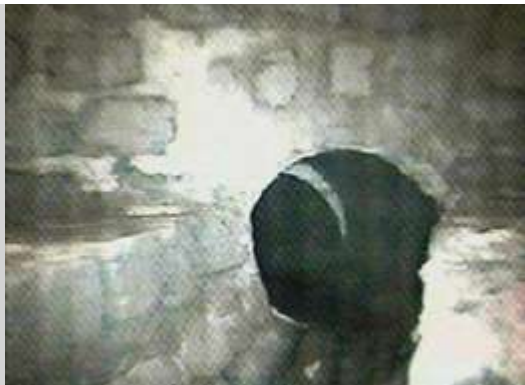
8 in. Circular Gravity Sewer Pipe In @ 4 O'Clock

Infiltration: **None** Pipe Seal Cond: **Unknown**

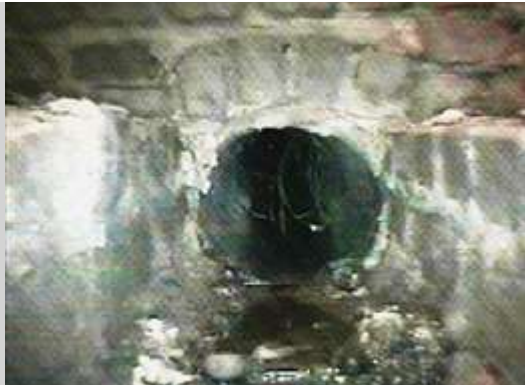
Pipe In @ 6 O'Clock

Deposits: ☐ None ☐ Mud ☐ Sludge ☒ **Debris** ☒ **Grease**

Deposits Extent: **Light**

Infiltration: **Evidence**
